Debris/Ice/TPS Assessment and Integrated Photographic Analysis for Shuttle Mission STS-57

July 1993

Gregory N. Katnik
NASA/Kennedy Space Center

DEBRIS/ICE/TPS ASSESSMENT
AND
PHOTOGRAPHIC ANALYSIS
OF
SHUTTLE MISSION STS-57

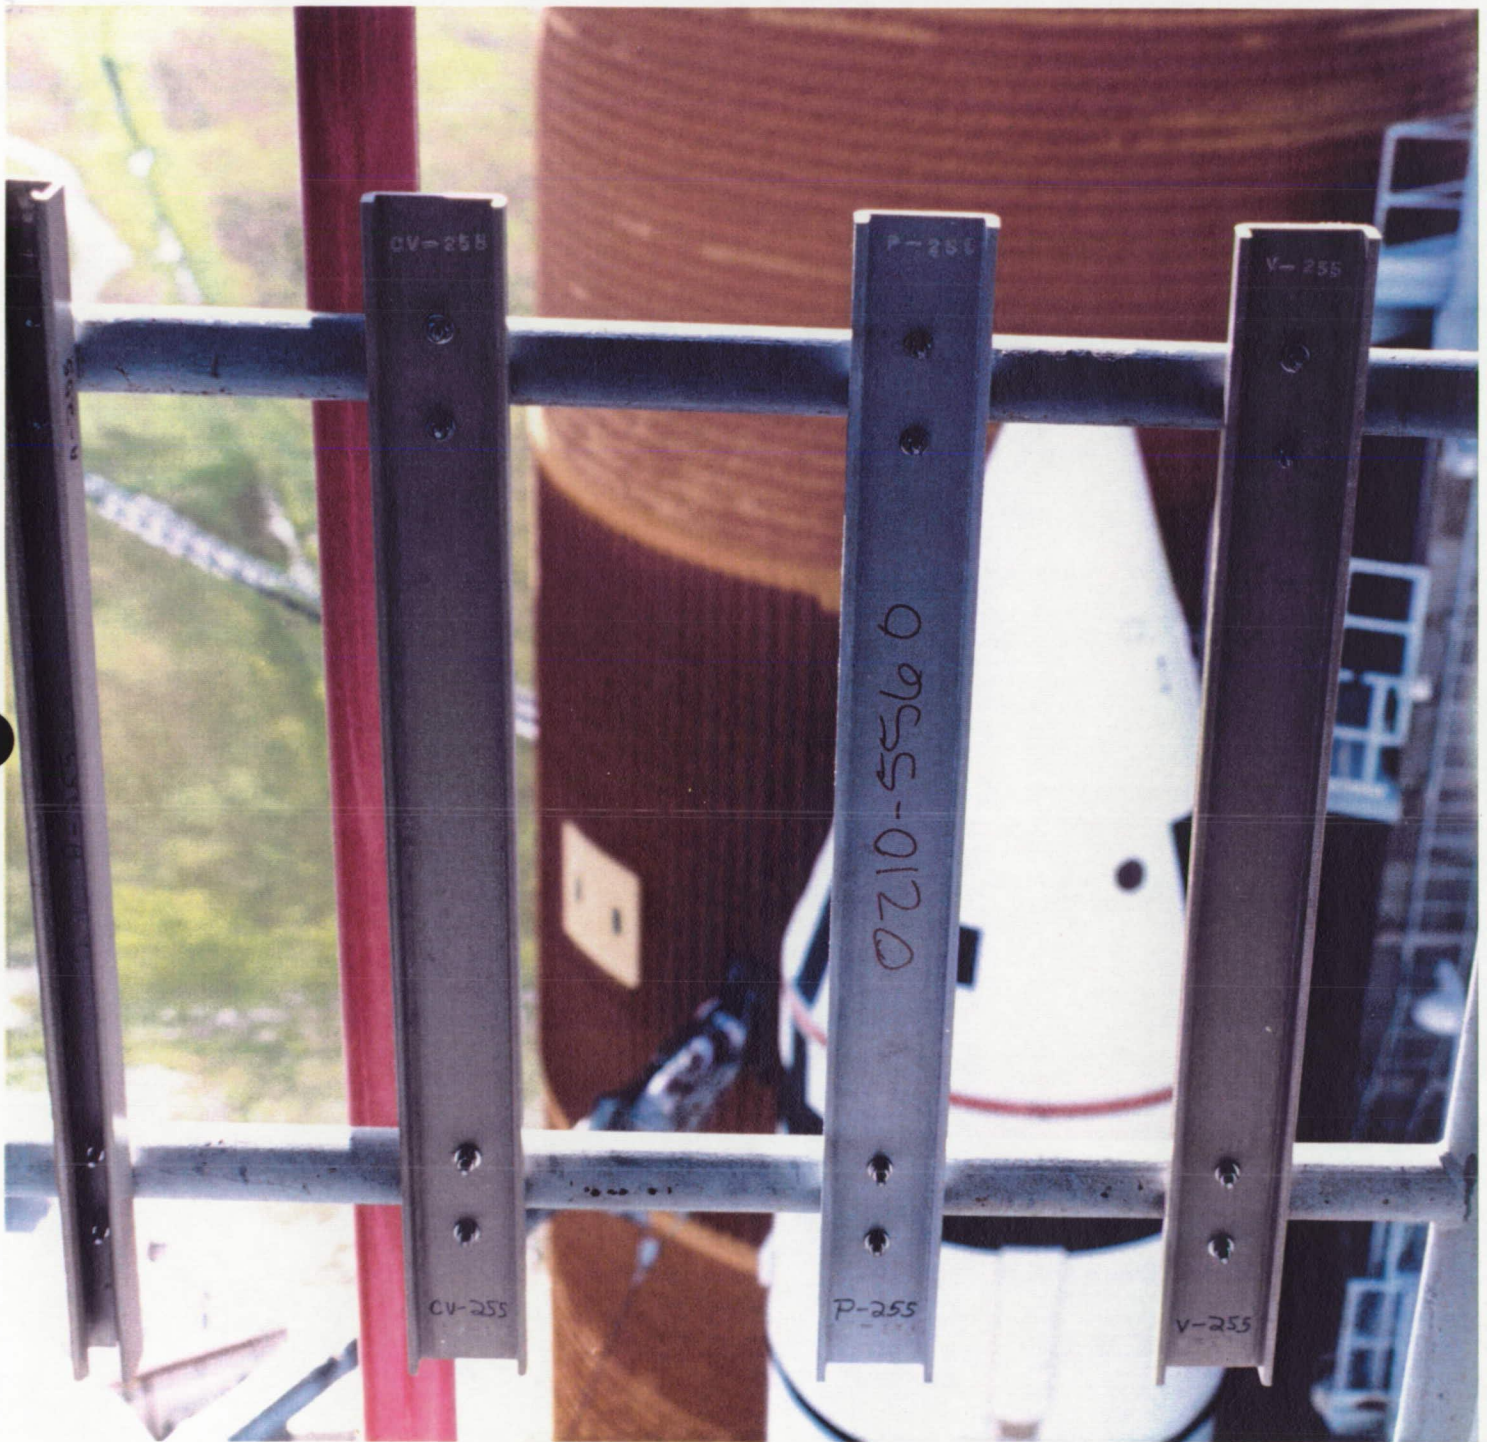
Four each composite material samples were U-bolted to the hand rails on the FSS 135, 175, 215, and 255 foot levels (east side). The Debris Team evaluated each installation and found no debris concerns.

Four each composite material samples were U-bolted to the hand rails on four levels of the FSS east side

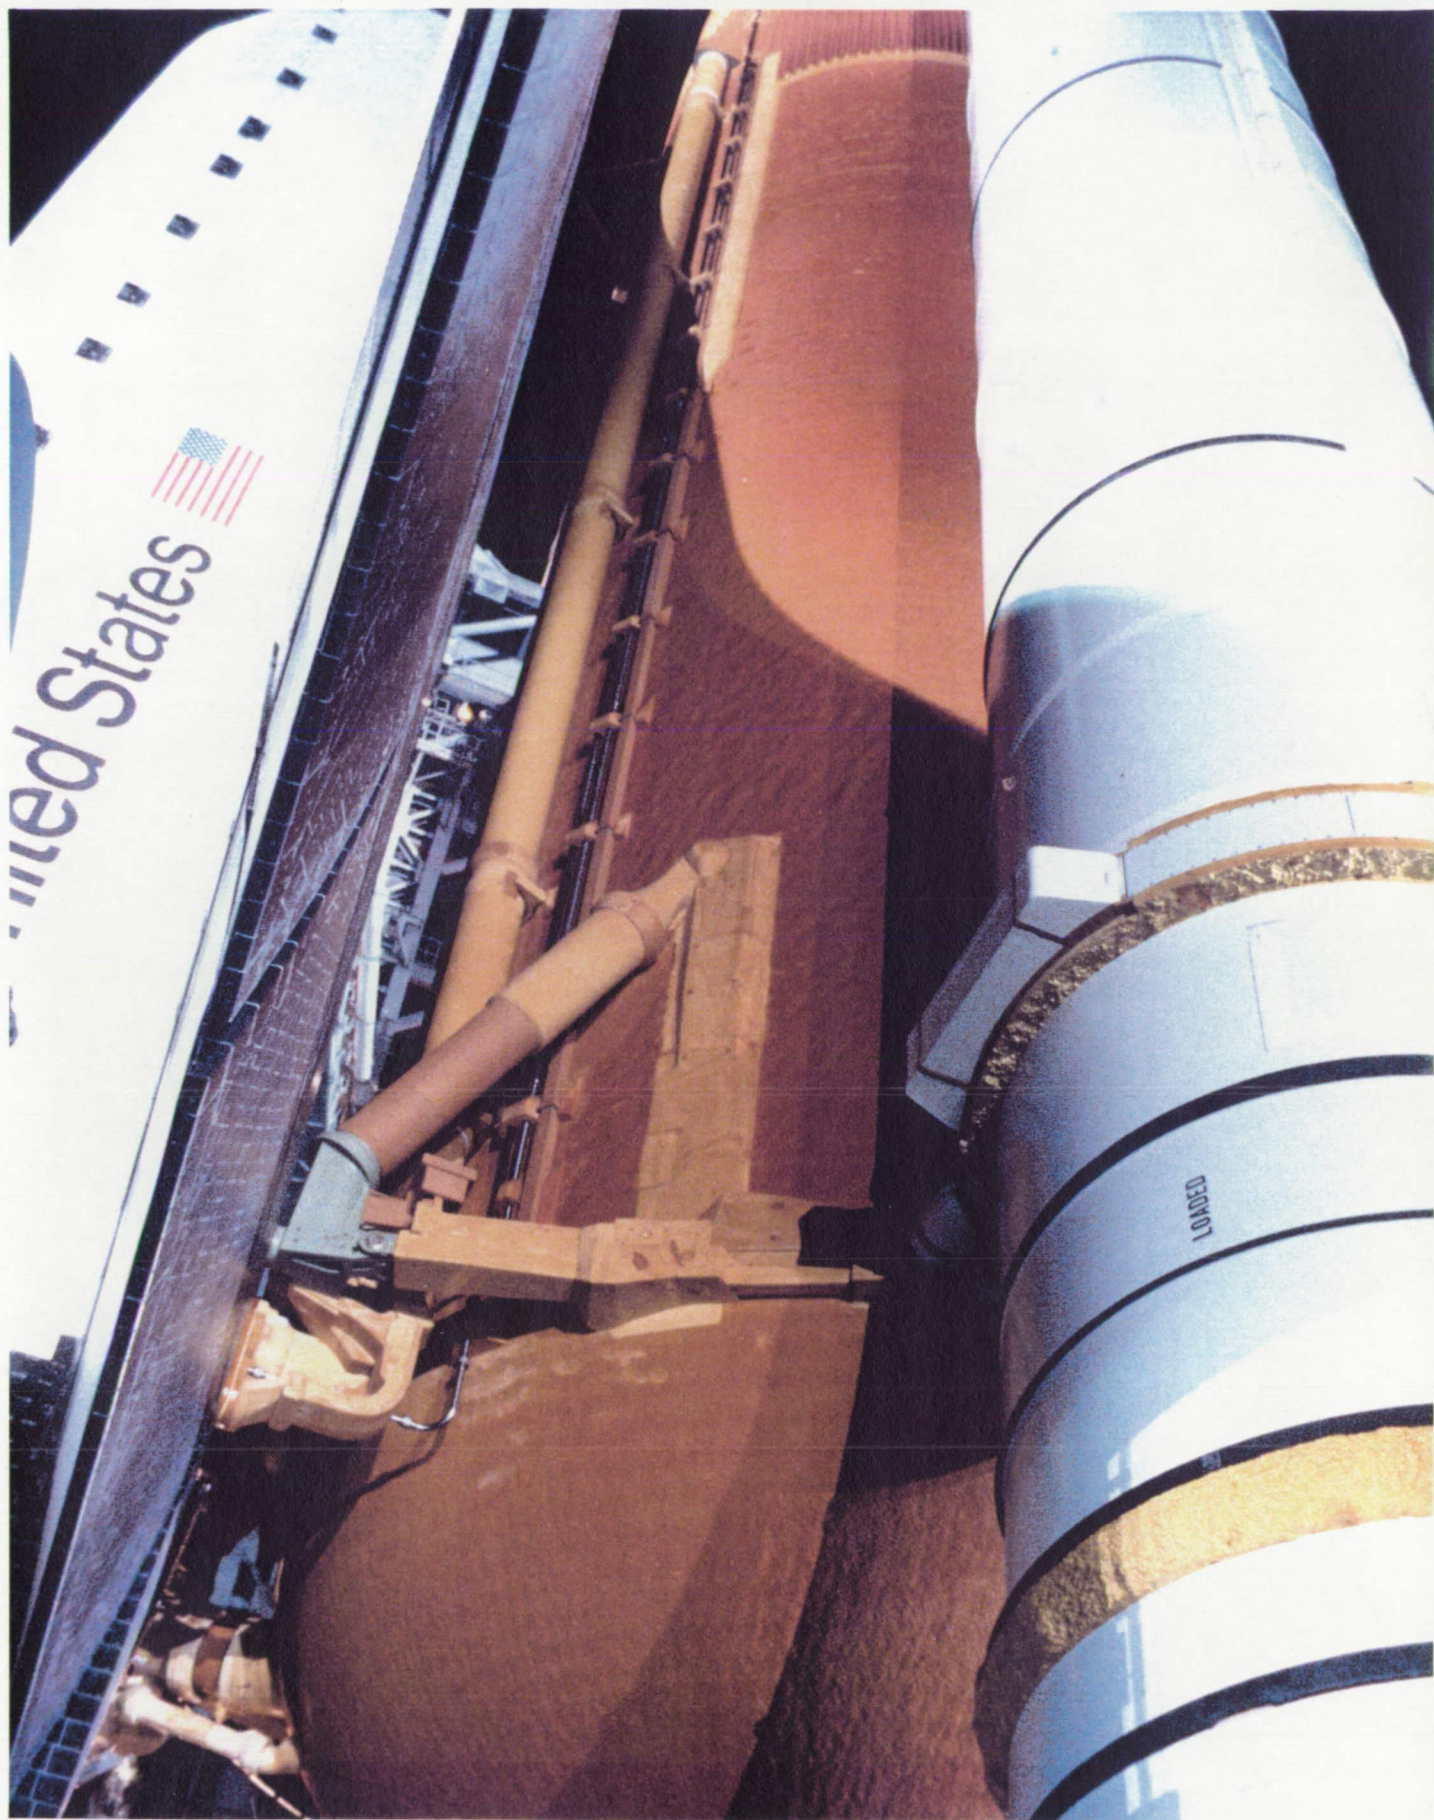
Condensate, but no ice or frost, was present on the LH2 tank acreage. There were no acreage TPS anomalies.

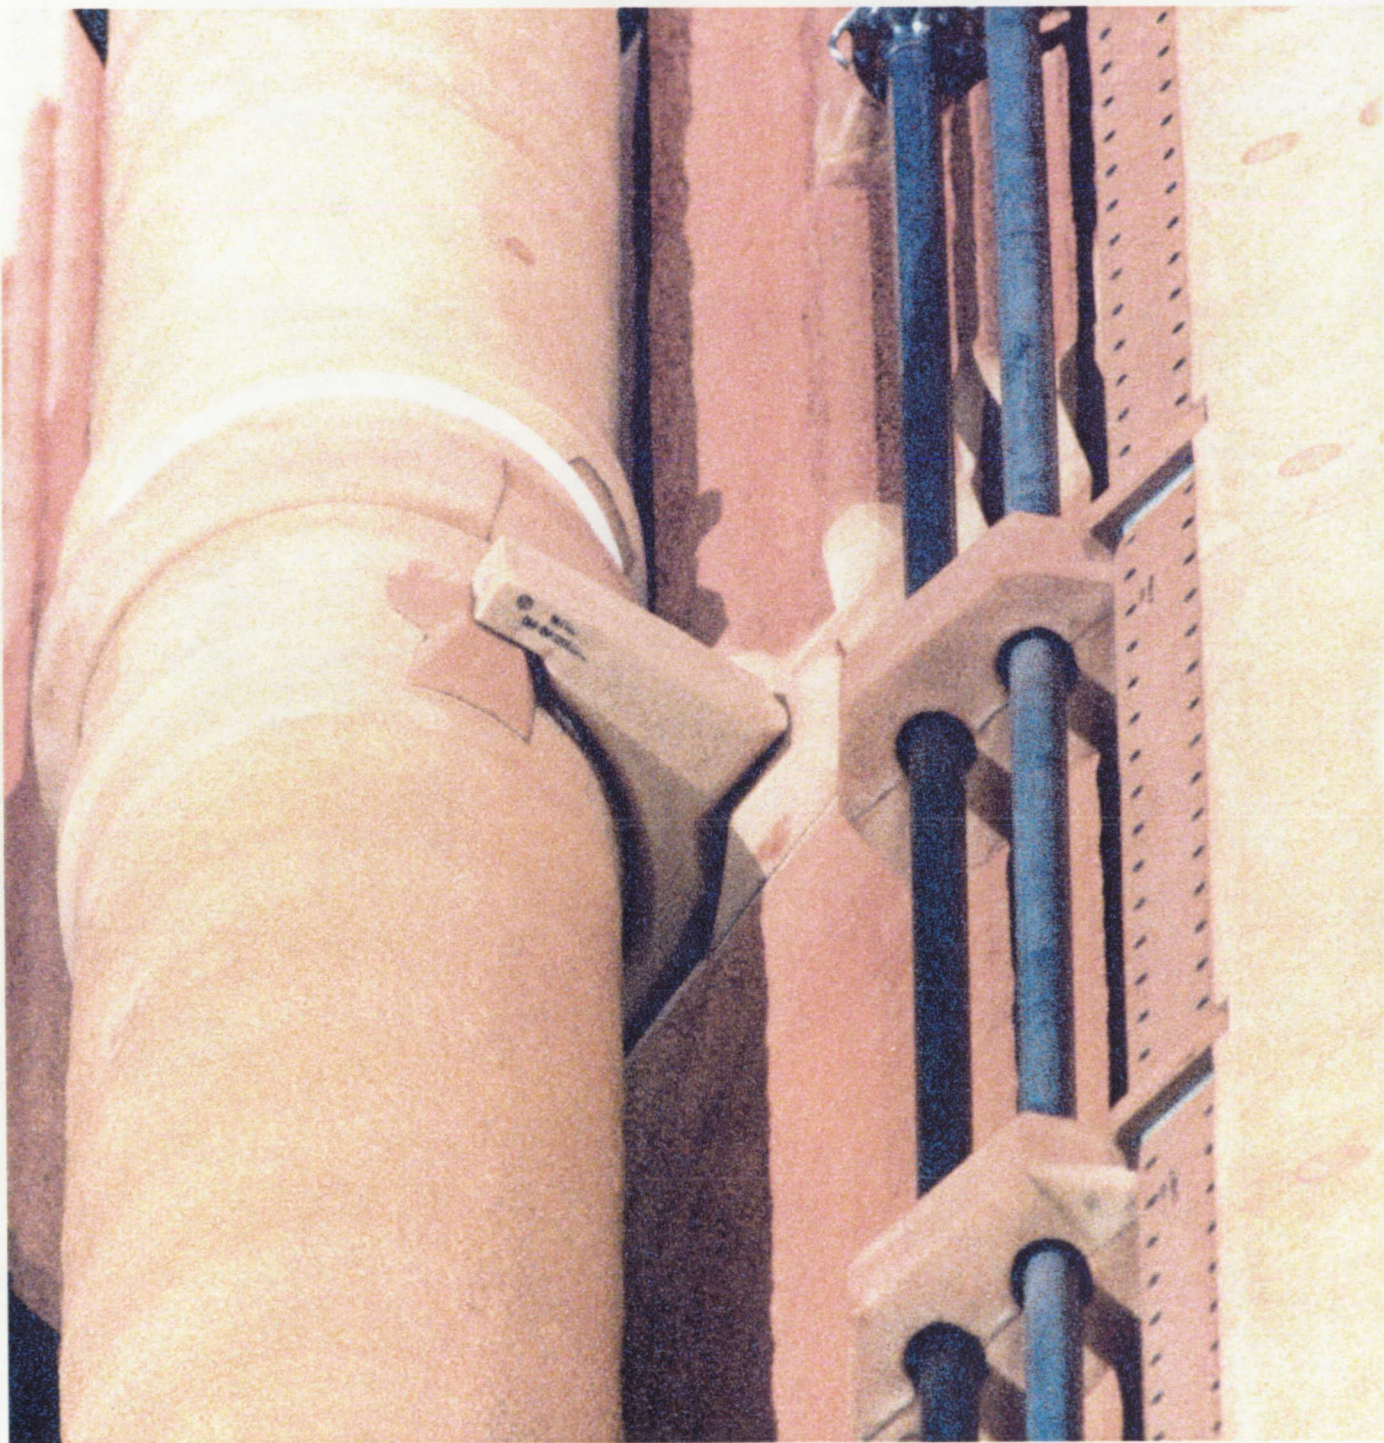
Ice/frost accumulations in the LO₂ feedline bellows
and support brackets was typical

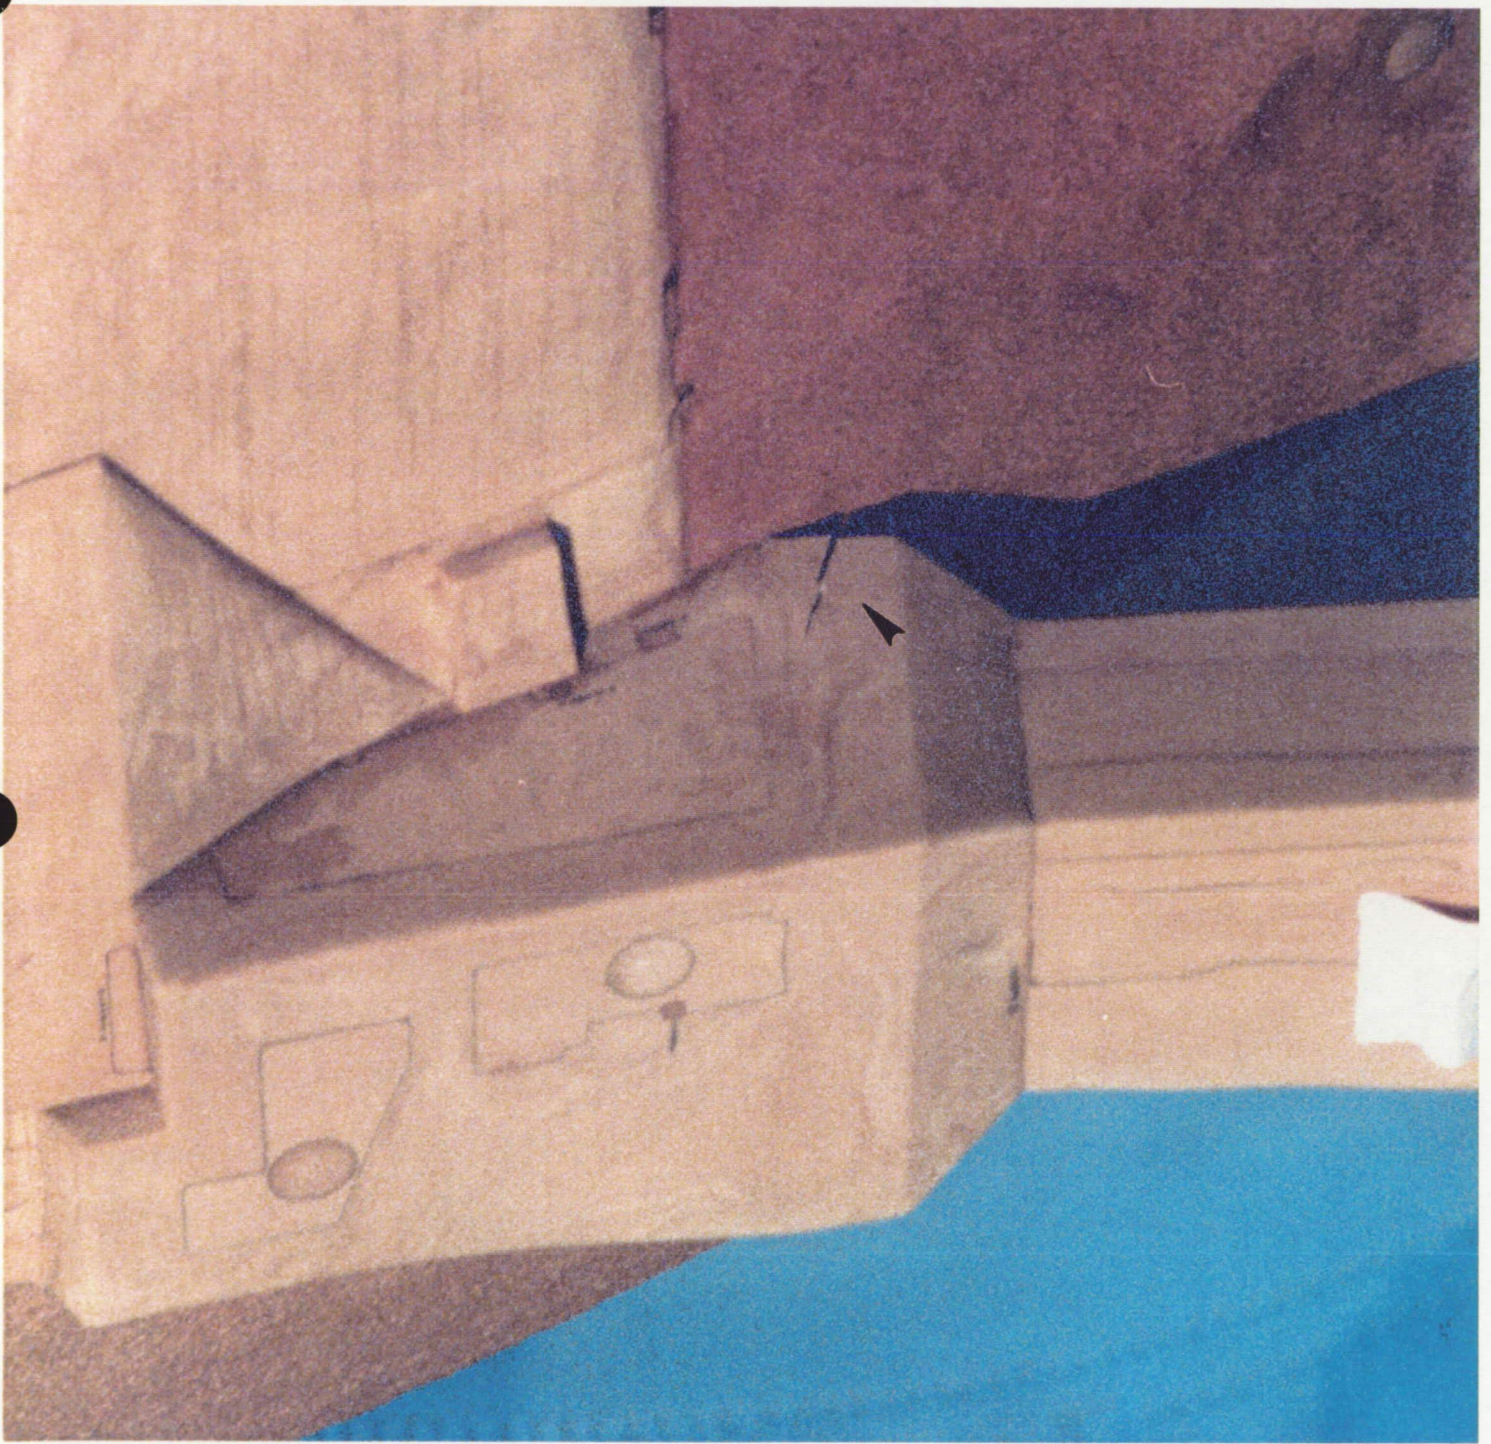
Anomaly 001 documented a 6-8 inch long by 3/8-inch wide crack in the -Y vertical strut cable tray forward surface near the longeron closeout interface. The crack exhibited no offset and was not filled with ice or frost.

An 8-inch long by 3/8-inch wide crack occurred in the -Y vertical strut cable tray forward surface TPS near the longeron closeout interface. The crack exhibited no offset and was not filled with ice or frost. The presence of the crack was acceptable for flight per the NSTS-08303 criteria.

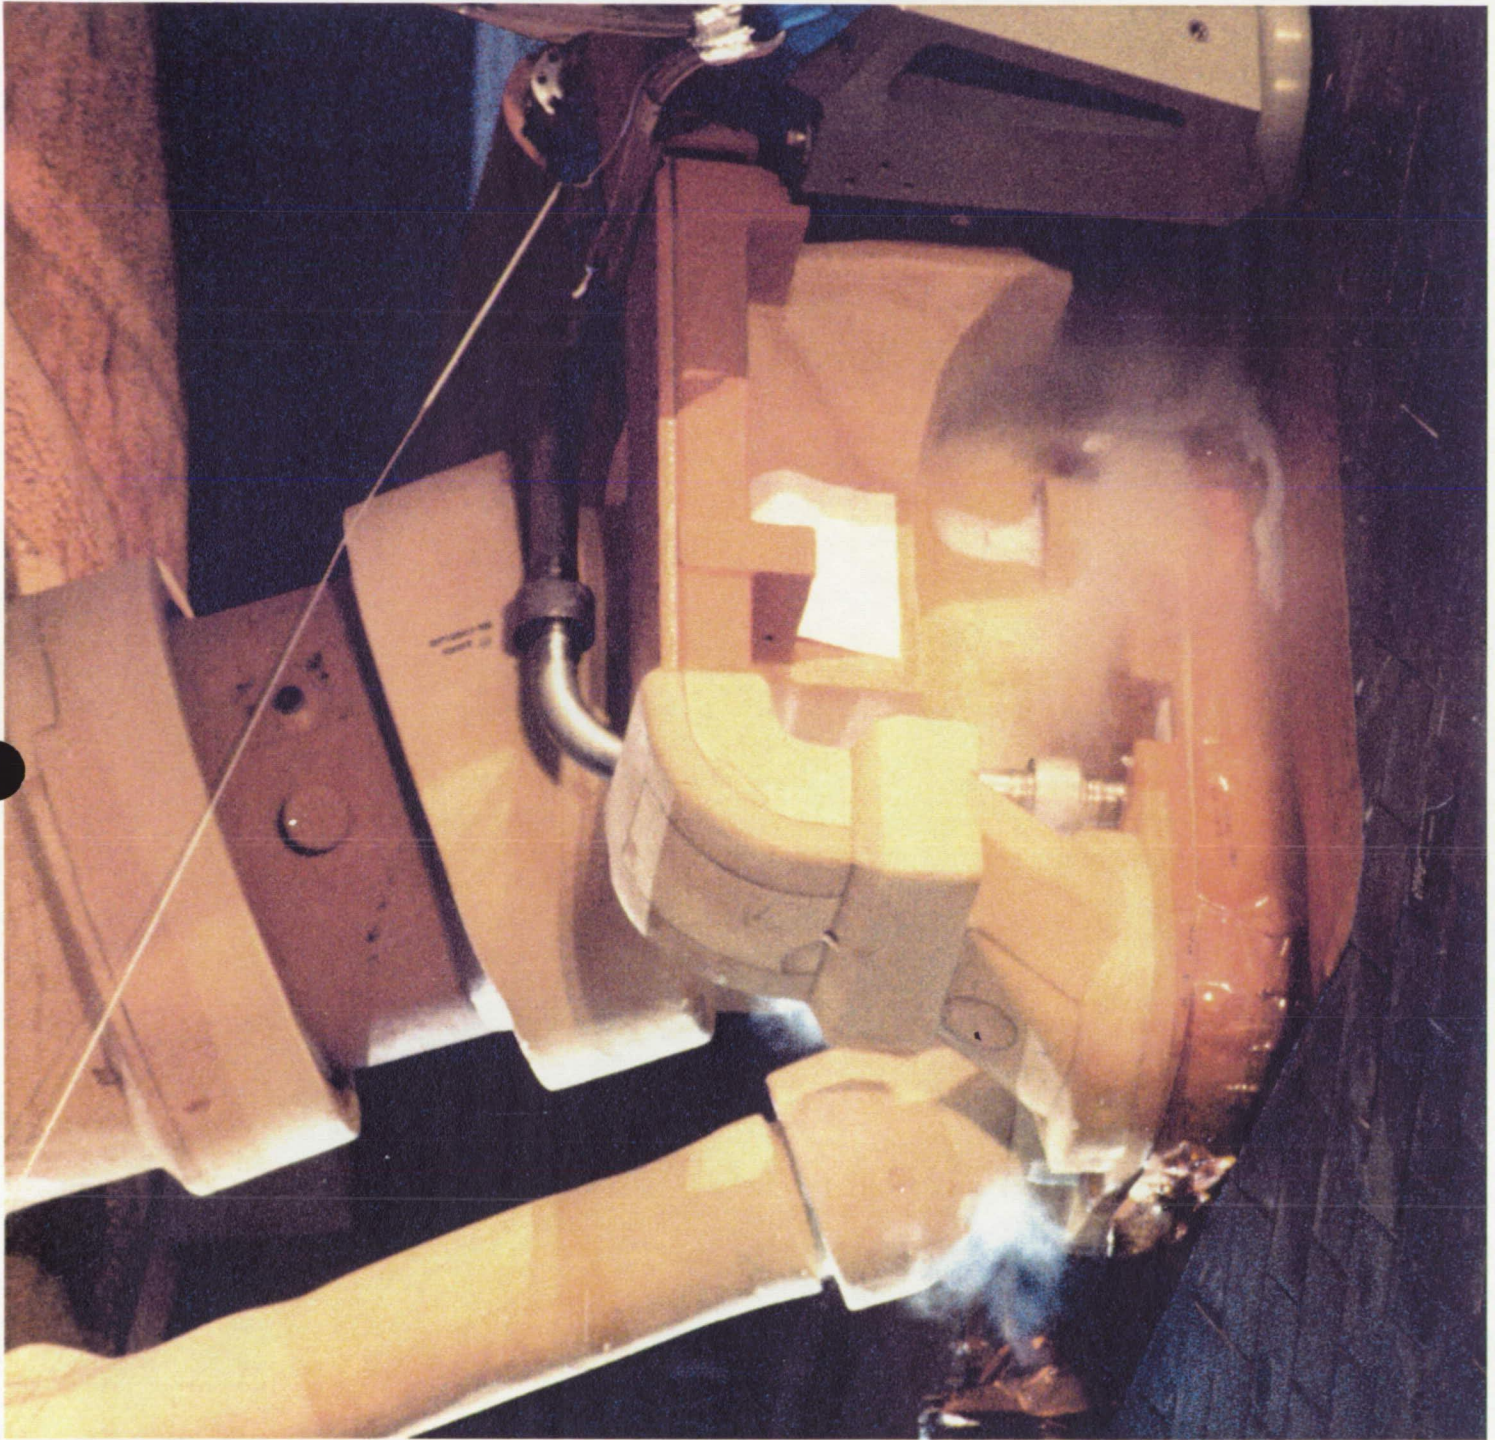
Less than usual amounts of ice/frost had formed on the ET/ORB LH2 umbilical. No cryogenic drips or unusual vapors appeared during tanking, stable replenish, and launch.

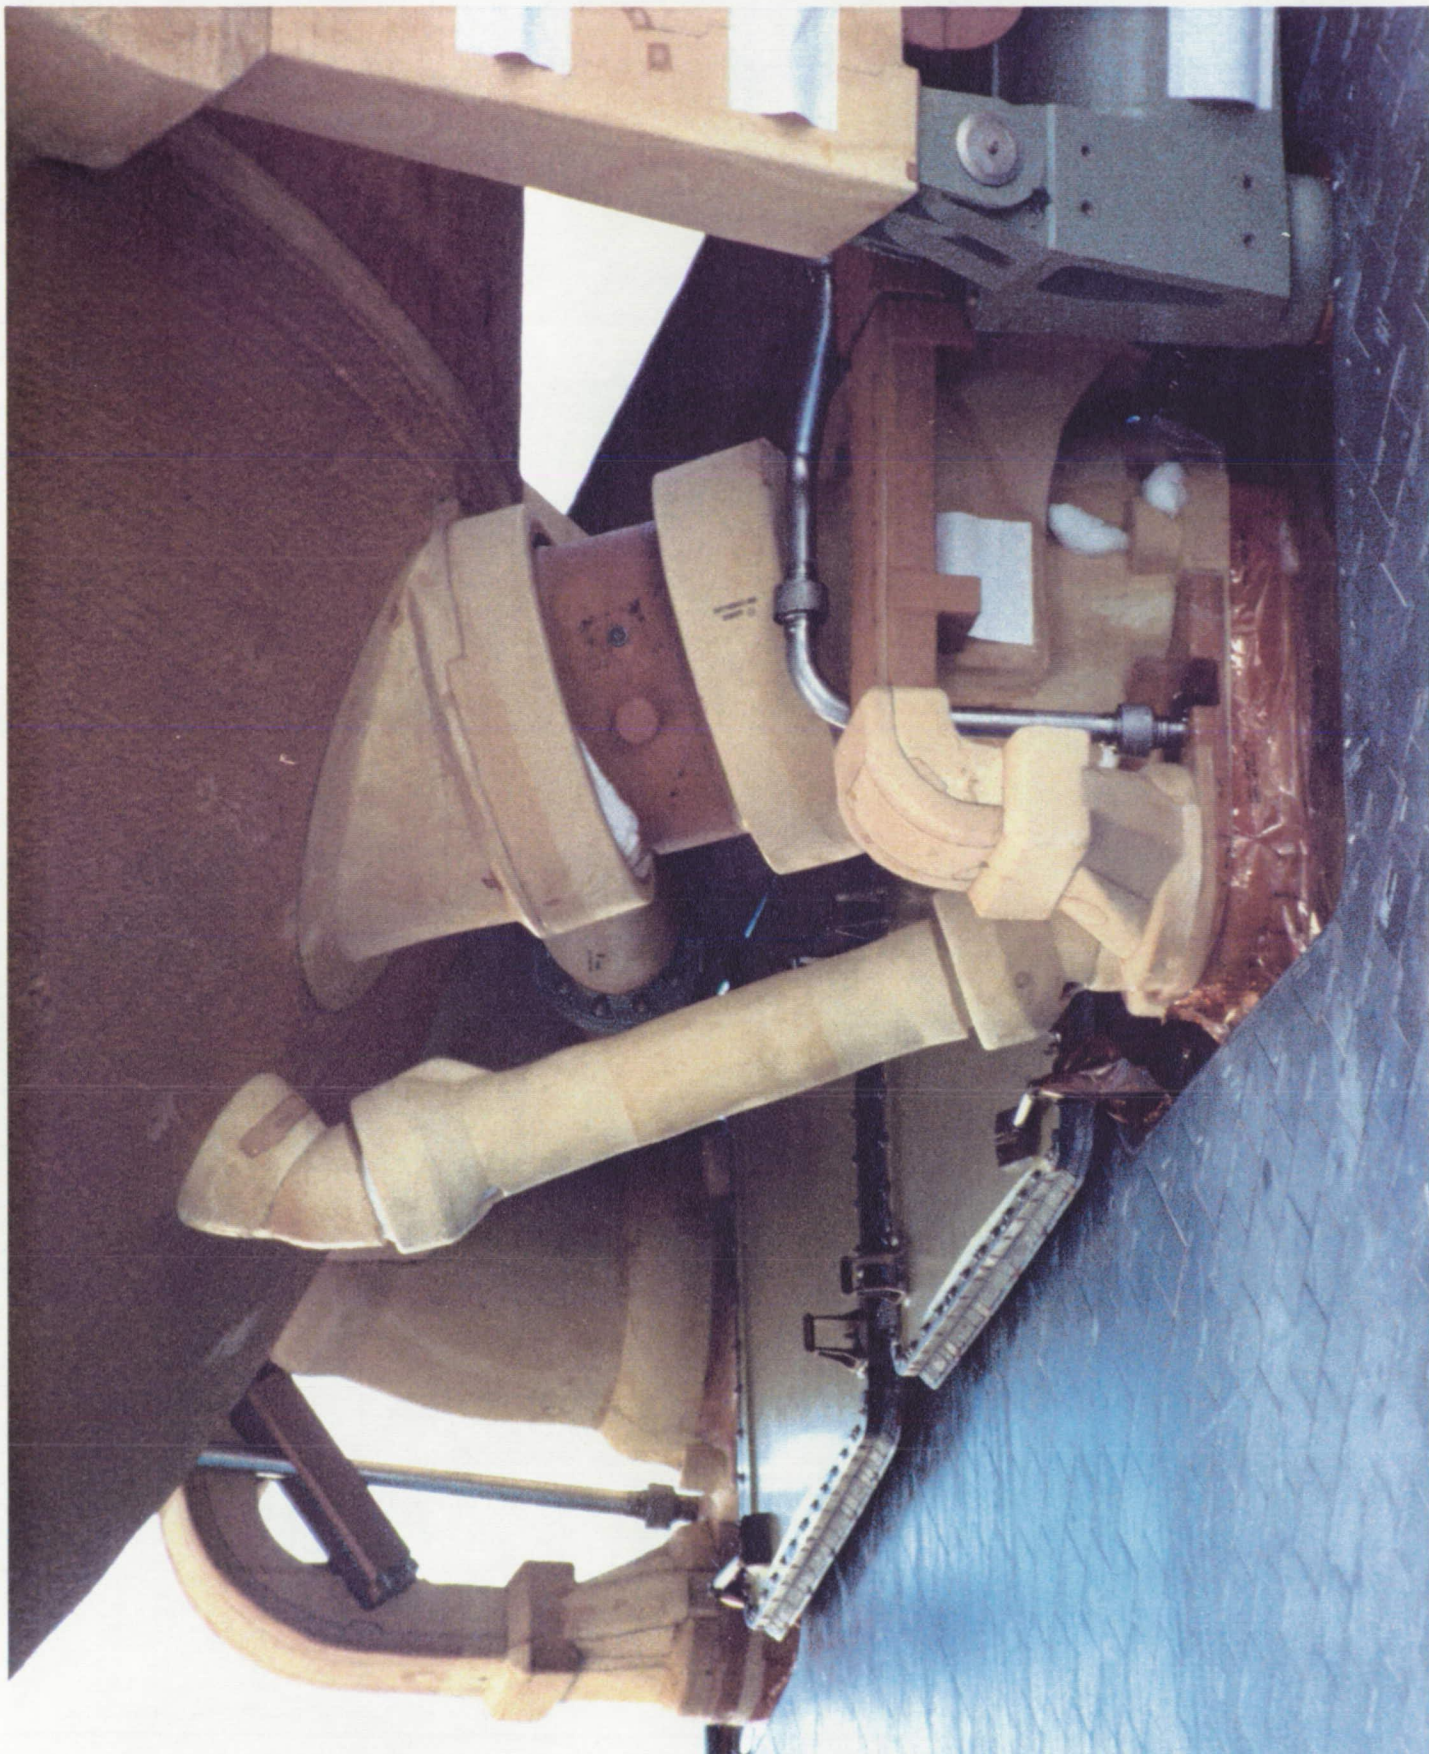
Post drain inspection revealed ice on the pyro canister purge vents, plate gap purge vents, LH2 recirculation line bellows, and LH2 feedline bellows - an expected condition. There were no TPS anomalies.

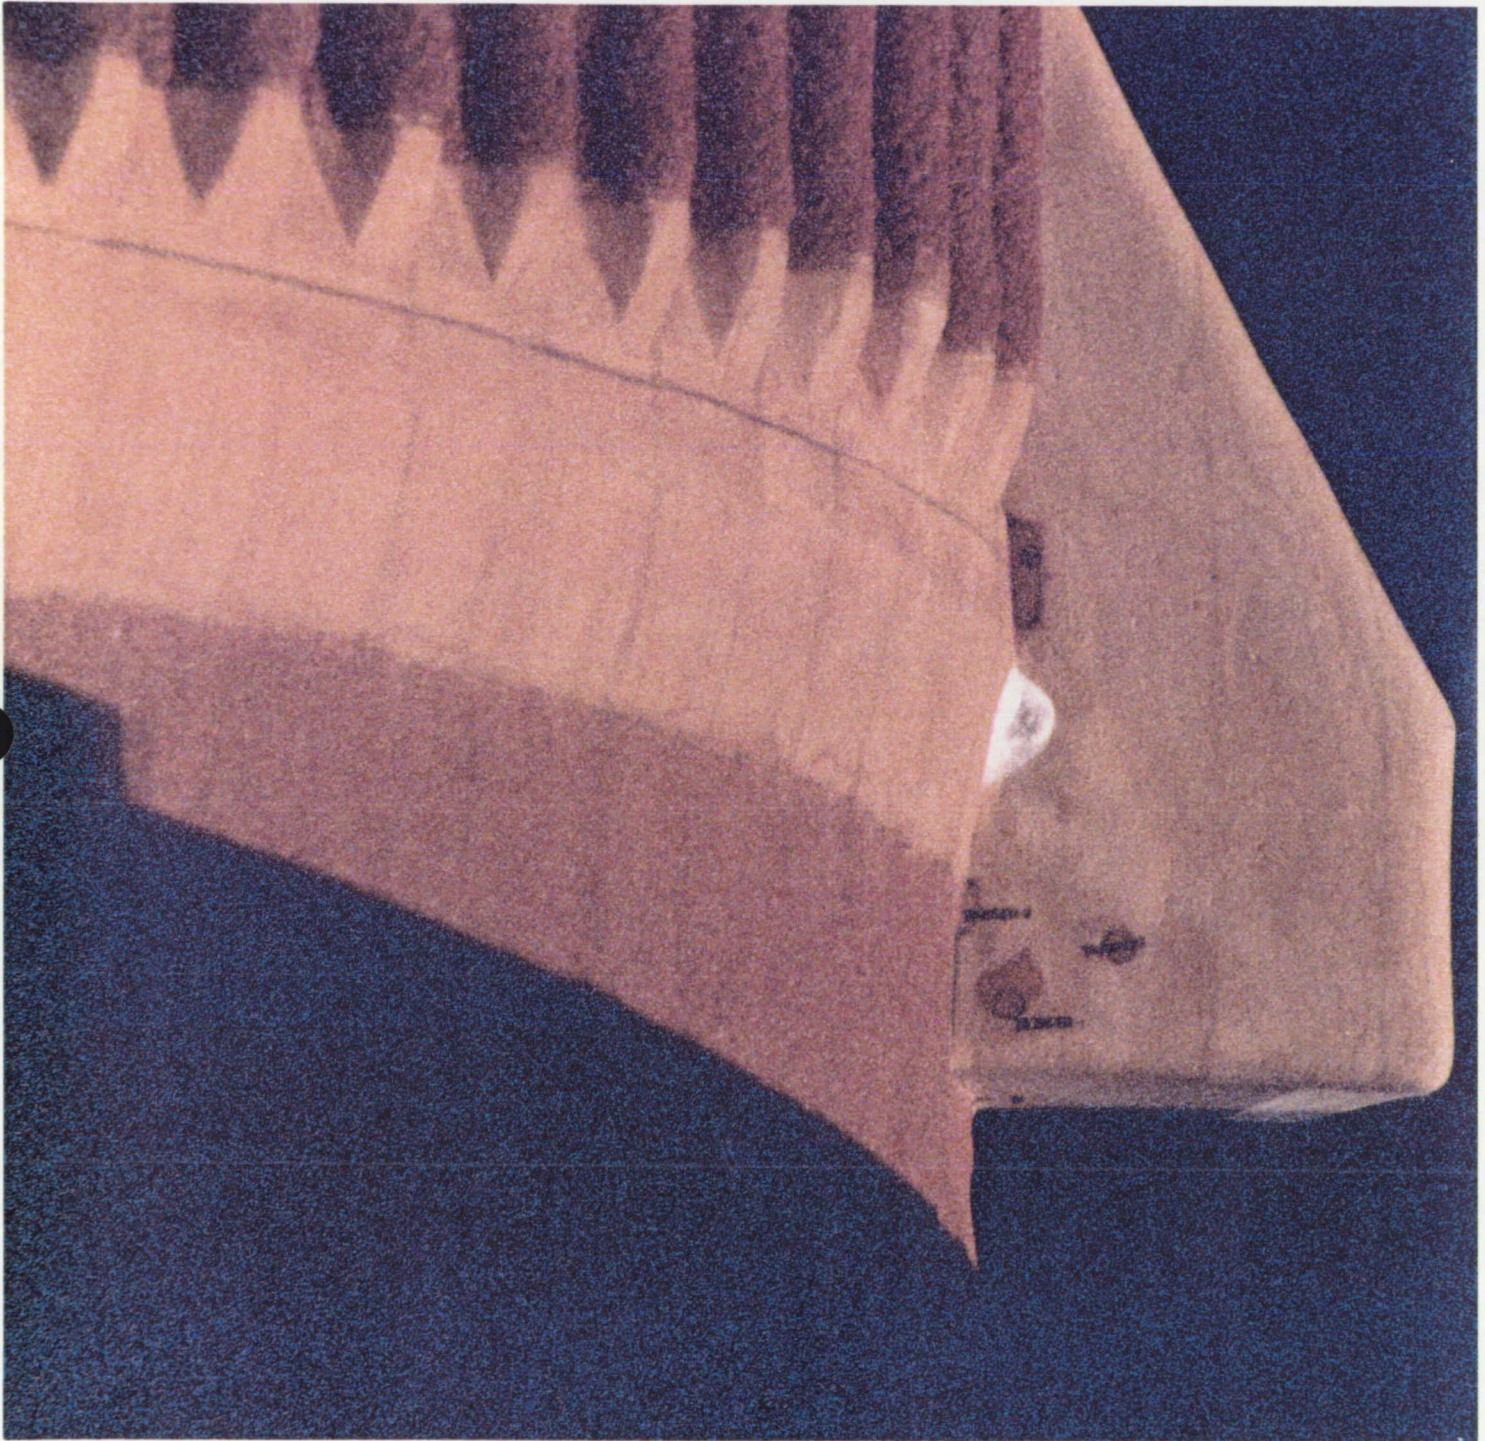
A 2-inch diameter ice/frost accumulation, which first appeared during drain, had formed on the -Y bipod spindle housing-to-ET interface bondline.

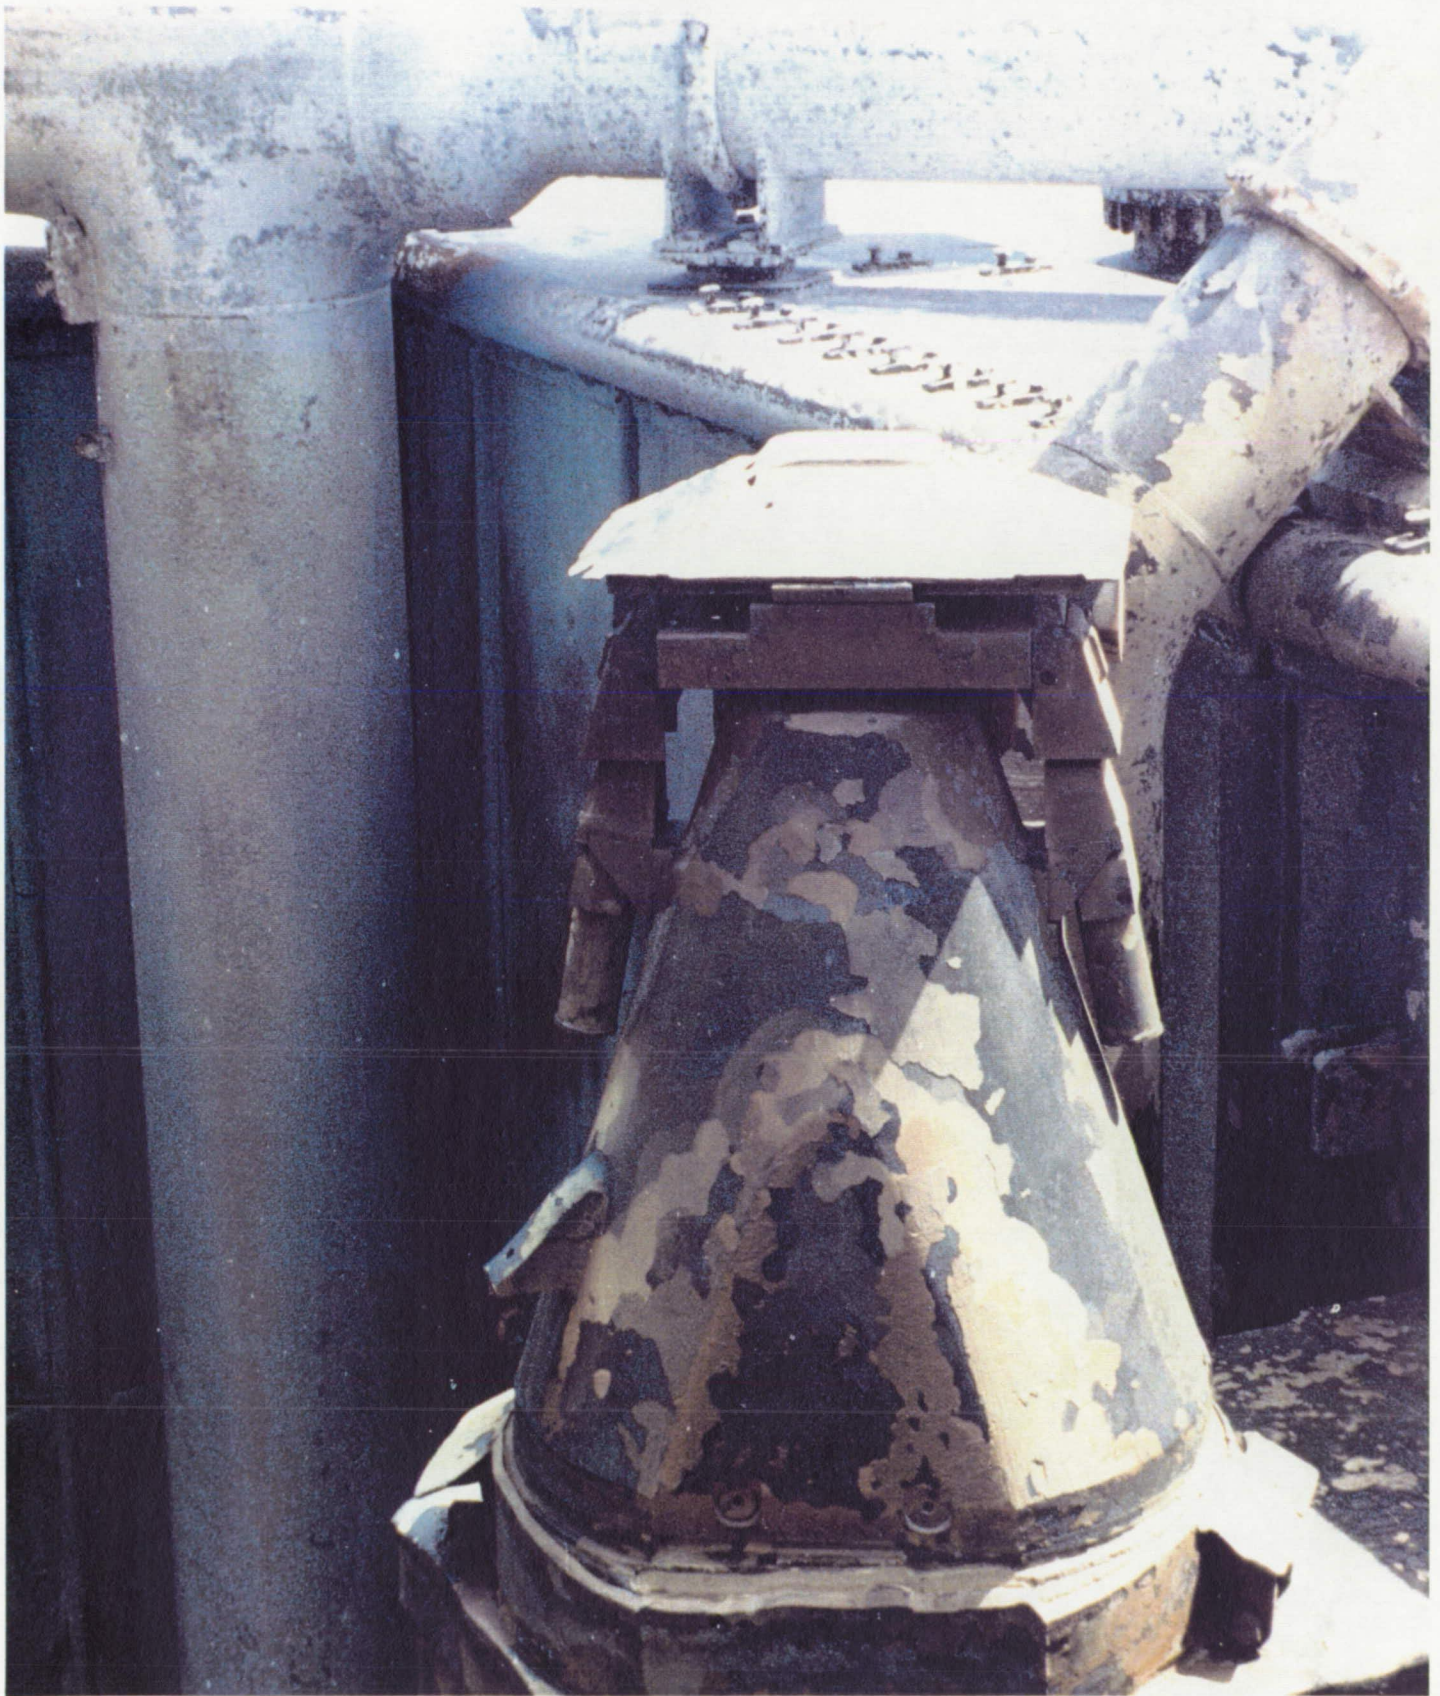
SRB plume erosion of the north HDP blast covers was typical with the exception of the HDP #4 cover, which had several burn-through holes.

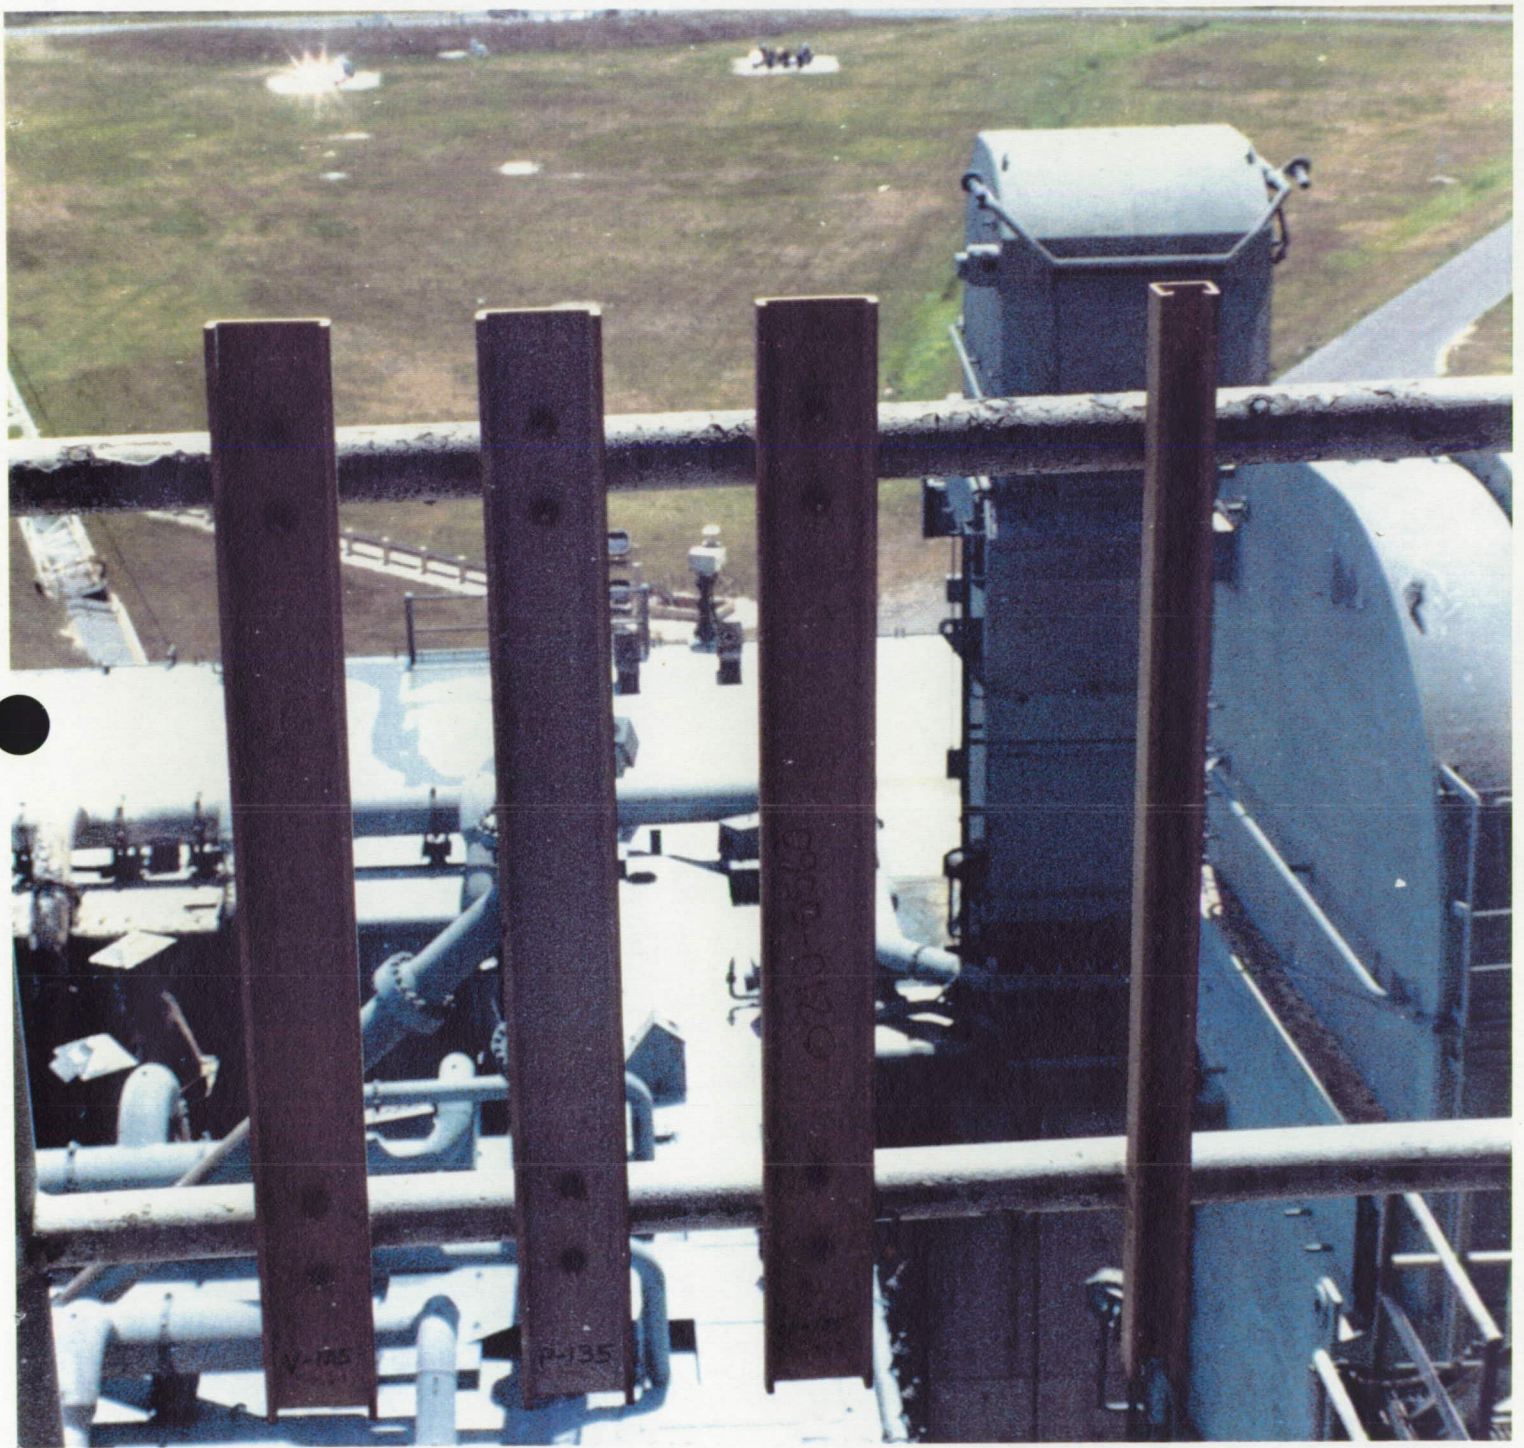
All composite material samples attached to the
FSS east side handrails were intact and undamaged

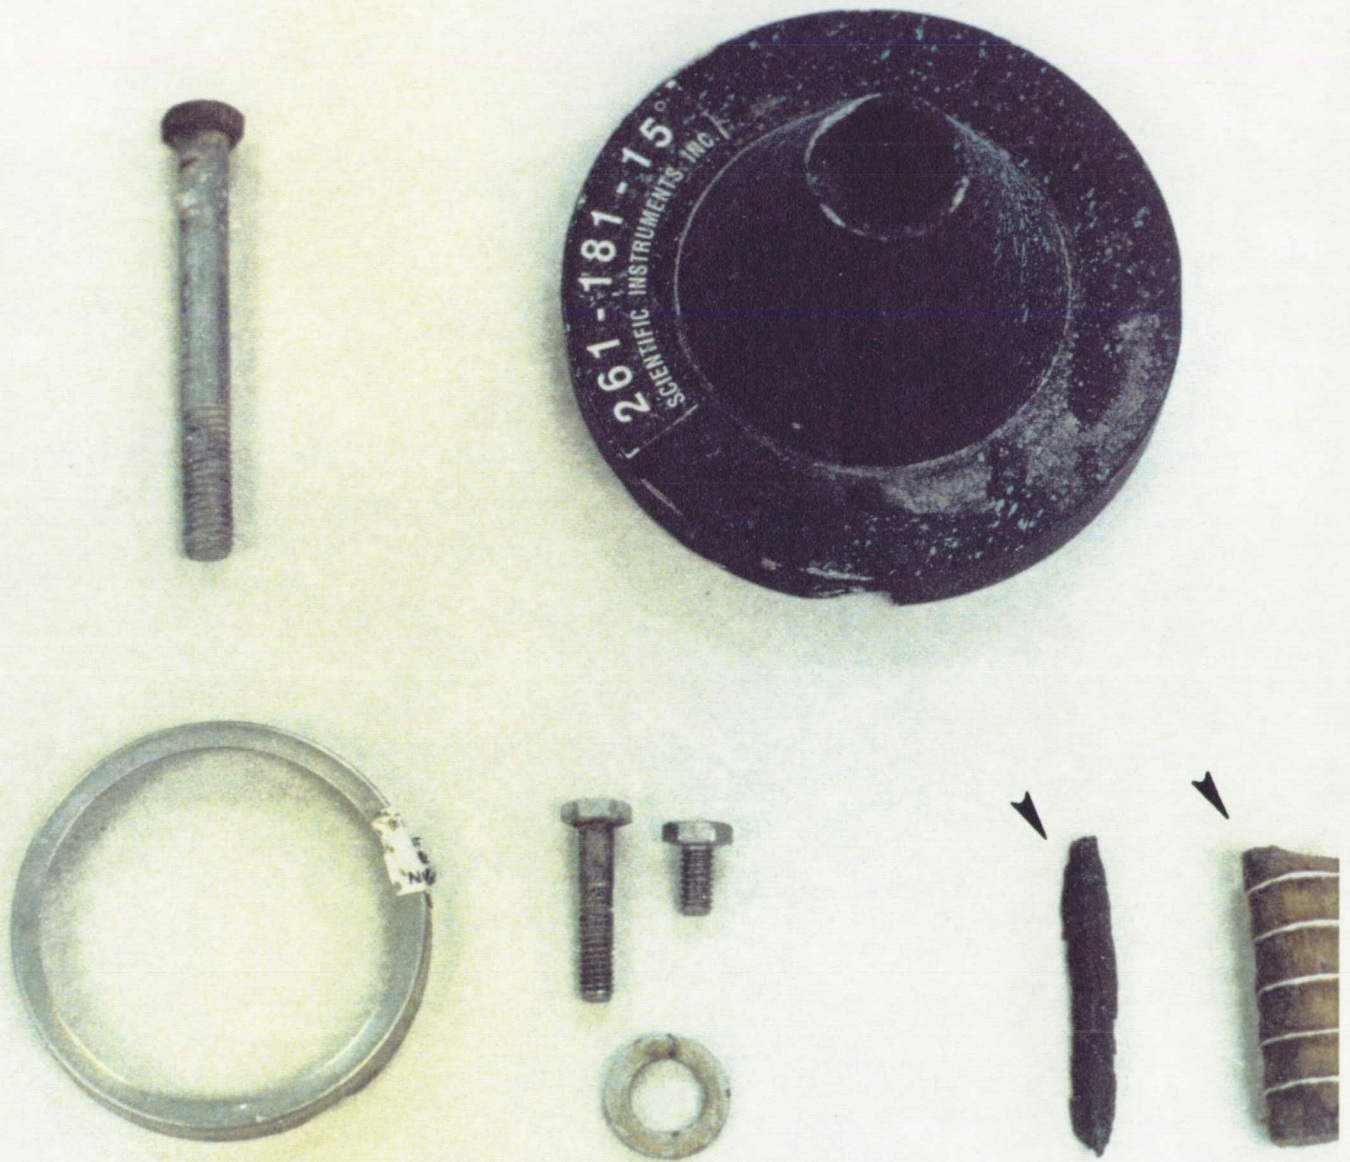
A frangible nut web, 2-1/4" by 5/16", was found on the stud in holddown post #2. A Q-felt plug from the Orbiter base heat shield was found on the southwest pad apron.
